**HISTORY OF SITE OPERATIONS BY  
TEXTRON SYSTEMS CORPORATION  
(104E REQUEST)  
J-1 AND J-3 RANGES  
CAMP EDWARDS, MASSACHUSETTS**

*Prepared for:*

**Textron Systems Corporation  
201 Lowell Street  
Wilmington, MA 01887**

**Harding Lawson Associates  
107 Audubon Road  
Wakefield, MA 01880**

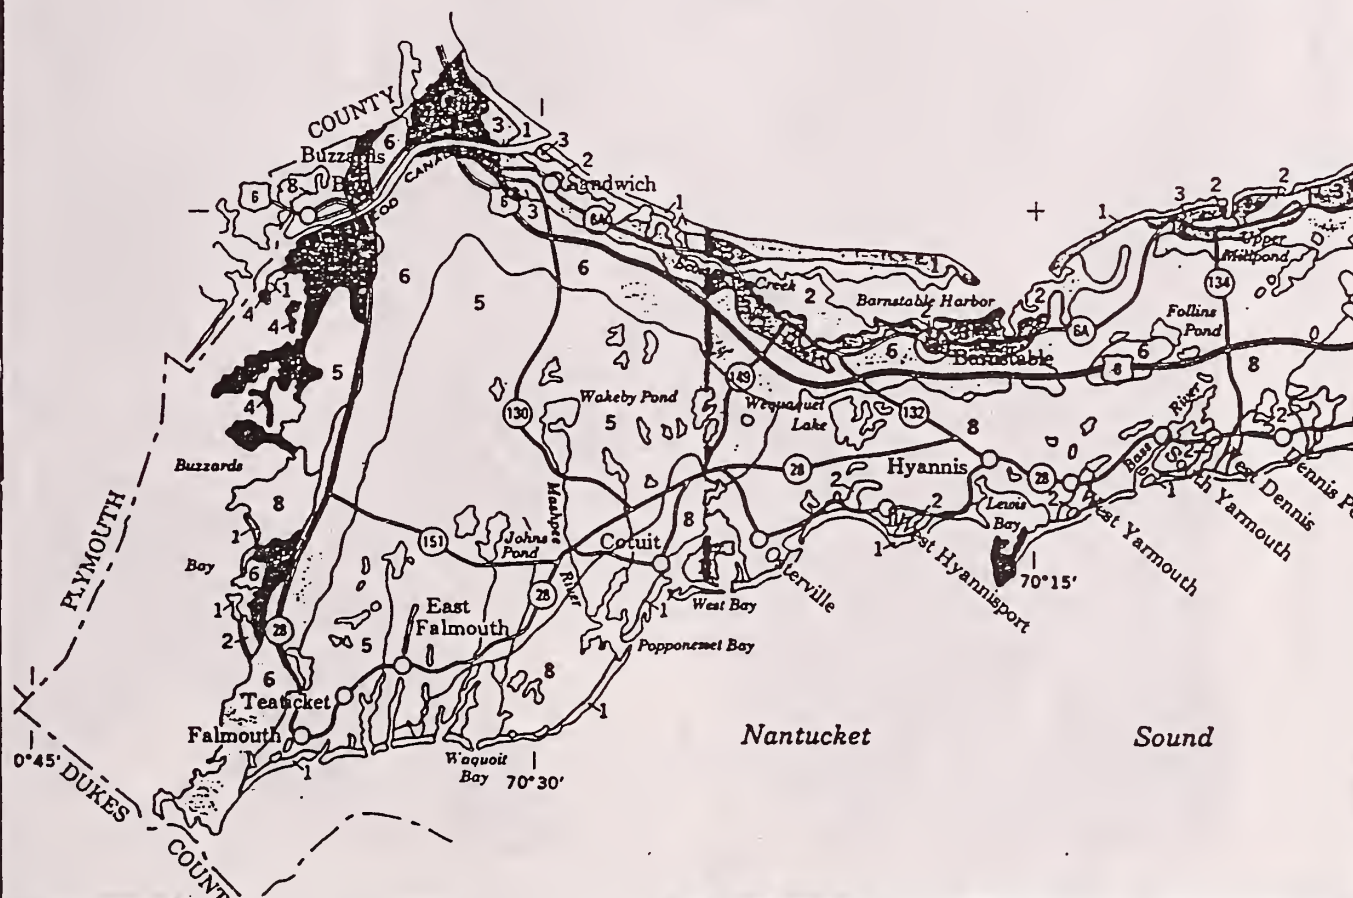
FIGURE C-1  
**GENERAL SOIL MAP CAPE COD**  
Textron Cape Operations J-3 Range  
Greenway Road  
Otis Air Force Base, Sandwich, MA
